***Unfolding the Life of a
Townhouse. Exploring 18th -
19th Century Townhouse
Renovations in Aizpute City.***

Balancing history with modern functionality.

Case study No 1 - Pasta street 5

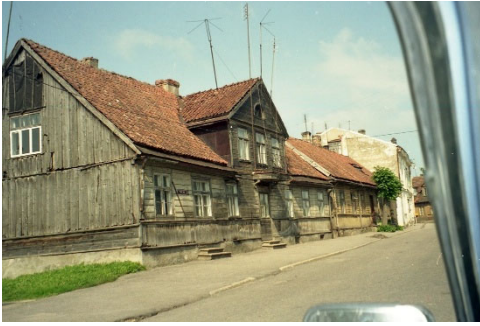
Figure 1. Image representing the visual state of townhouses at Pasta Street 3 and Pasta Street 5, Aizpute. 20th century 60-70s.

Investigation suggests that the building's volume and façade finishes have largely remained intact since the latter half of the 19th century. The structure is a single-story wooden building with a dual-pitched roof, forming an "L" shape. It is constructed from log beams in a post-and-beam framework, later treated with tar, and the roof is covered with clay tiles and shingle lining (Figure 1) (Ziemele, 1992).

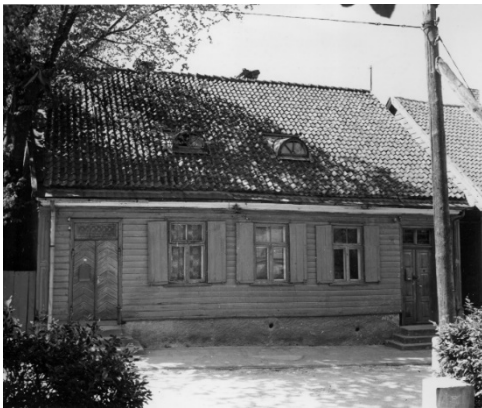
Figure 4. Facade of the building on Kuldīgas street 5, 60-70s of the 20th century, showing the building's well-preserved facades. Archive material of the Aizpute Local History Museum.

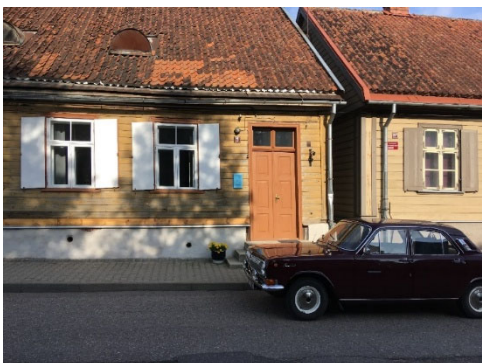
Figure 5. Image revealing renovated facade of the building on Kuldīgas street 5, renovated in 2022. Photo from owners archives.

century and other interior elements. The owner also sees the renovation of the habitable attic space on the second floor as an unrealized potential. Building facades, roof covering and details of windows and doors have been preserved or restored as found in historical images, for example the white insides of window shutters characteristic of city Aizpute.
